INDOOR AIR QUALITY ASSESSMENT

Lynnfield Middle School 505 Main Street Lynnfield, Massachusetts 01940

Prepared by:
Massachusetts Department of Public Health
Center for Environmental Health
Emergency Response/Indoor Air Quality Program
August 2006

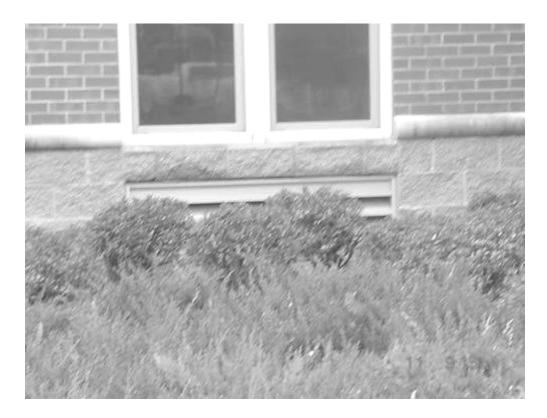
Plants were noted in several classrooms and in close proximity to univent air intakes outside the building (Picture 1). Plants can be a source of pollen and mold, which can be respiratory irritants for some individuals. Plants should be properly maintained and equipped with drip pans. Plants should also be located away from ventilation sources (e.g., air intakes, univent diffusers) to prevent the entrainment and/or aerosolization of dirt, pollen or mold.

Univent Fresh Air Intake, Note Shrubbery in Front of Vent

- 12. Move plants away from outside air intakes and univent air diffusers in classrooms.

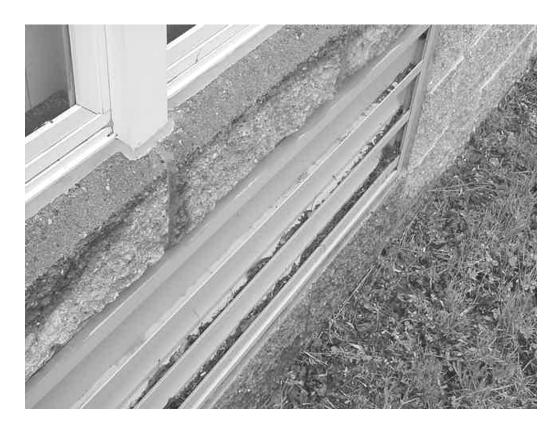
Fresh air in classrooms is supplied by computerized unit ventilator (univent) systems (Figure 1). A univent draws air from the outdoors through a fresh air intake located on the exterior wall of the building (Pictures 1 and 2) and returns air through an air intake located at the base of the unit. Fresh and return air are mixed, filtered, heated and provided to classrooms through an air diffuser located in the top of the unit. Adjustable louvers control

Univent Fresh Air Intake, Note Plant Debris in Intake Louvers

- 13. Consider discontinuing the use of mulch in alcove areas outside of rooms 103 (203) and 113 (213) to prevent the entrainment of musty odors.
- 14. Examine the feasibility of replacing or modifying the exterior of univent fresh air intakes to prevent the accumulation of moss and debris.

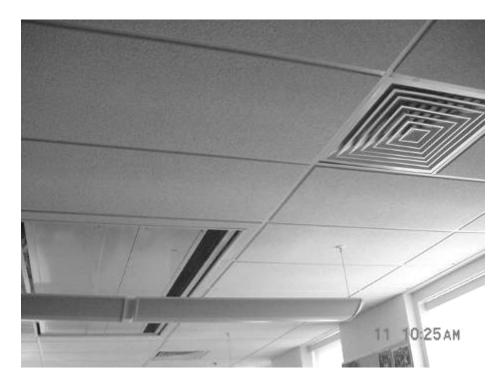
the ratio of outside to recirculated air. Some classrooms have univents installed above the ceiling that are ducted to classrooms via multi-directional air diffusers (Picture 3). Univents were found deactivated by occupants in a number of areas (Table 1). Obstructions to airflow, such as items stored on or in front of univents were seen in some areas. In order for univents to provide fresh air as designed, units must be activated while rooms are occupied and air diffusers should remain free of obstructions.

Ceiling Mounted Univent and Multi-Directional Air Diffuser

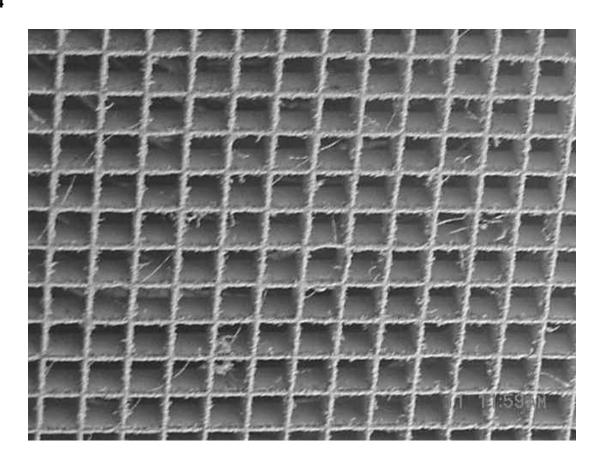
The mechanical exhaust ventilation system consists of ceiling-mounted exhaust vents (Picture 4) ducted to rooftop motors. Two rooftop exhaust motors, that service half the classrooms, were not functioning during the assessment. Without sufficient supply and exhaust ventilation, environmental pollutants can build up and lead to indoor air quality/comfort complaints.

A number of exhaust/return vents and personal fans had accumulated dust (Picture 4). If exhaust vents are not functioning, backdrafting can occur, which can re-aerosolize dust particles. In addition, these materials can accumulate on flat surfaces (e.g., desktops, shelving and carpets) in occupied areas and subsequently be re-aerosolized causing further irritation.

Ceiling-Mounted Exhaust Grill

- 17. Store cleaning products properly and out of reach of students.
- 18. Clean fans blades, exhaust and supply vents periodically to prevent excessive dust build-up.

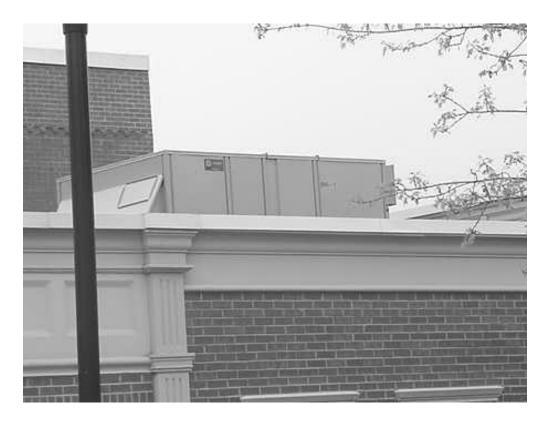
Mechanical ventilation in common areas (e.g., gym, cafeteria, media center) is provided by air handling units (AHUs) located on the roof (Picture 5) or in a penthouse. Outside air is heated or cooled and distributed to occupied areas via ceiling-mounted air diffusers and ducted back to AHUs through return vents.

Rooftop AHU

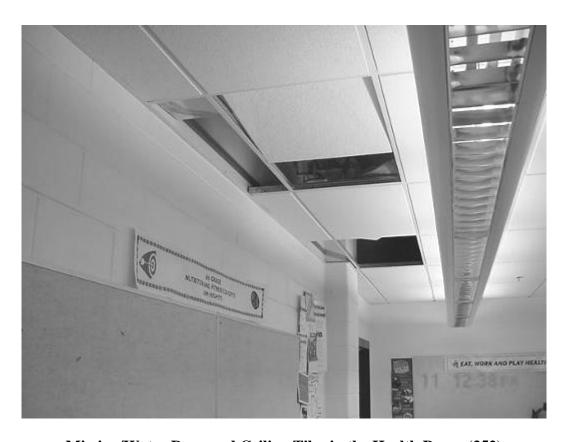
Several areas had water-stained ceiling tiles, which can indicate leaks from the roof or plumbing system. Water-damaged ceiling tiles can serve as a medium for mold and should be replaced after a water leak is discovered and repaired. Mr. Forbes reported that the building has had water infiltration issues through flashing, which the school department reportedly plans to address during the summer of 2006. Active leaks were reported in the health room (Picture 6), the music room (Picture 7) and in the stage area.

$Missing/Water\ Damaged\ Ceiling\ Tiles\ in\ the\ Health\ Room\ (352)$

- 10. Continue with plans to make repairs to flashing to prevent further water infiltration.
- Once repairs are made, replace water damaged ceiling tiles. Examine the area above and around water-damaged areas for mold growth. Disinfect areas with an appropriate antimicrobial as needed.

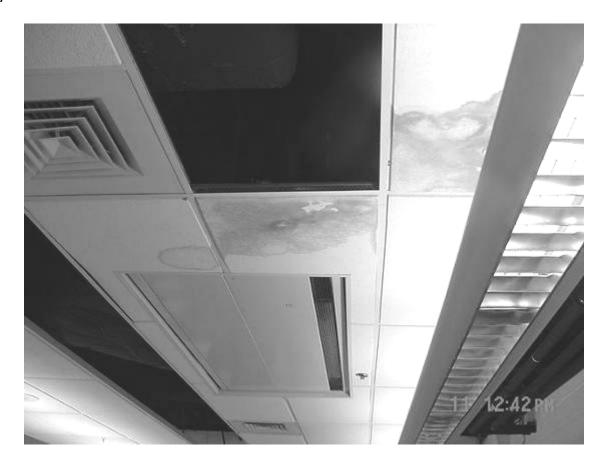
Missing/Water Damaged Ceiling Tiles in the Music Room (373)

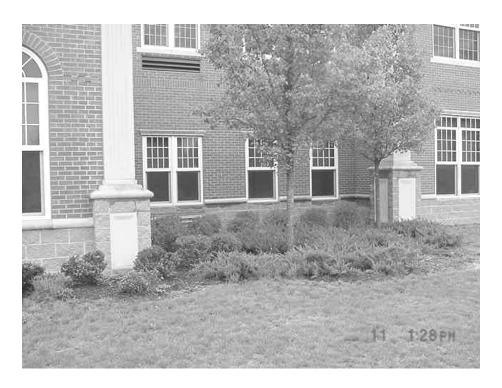
Musty odors were reported in several classrooms along the front of the building, specifically rooms 113, 213, 103 and 203 (Figure 2). CEH staff detected a musty-odor along the front of the building as well as in these rooms during the assessment. The odors appeared to be emanating from wet mulch along the front of the building. The contour of the building forms two alcoves where these classrooms are located (Picture 8); mulch in the alcove does not dry completely due to lack of sunlight (Figure 2). In addition, plant and other debris was observed on the inner lip of univent air intakes (Picture 2). The design of the fresh air intakes allow for water and debris accumulation inside the grilles, which can in turn be drawn into univents and distributed into occupied areas.

Mulch Bed in Alcove Outside of Classrooms 113/213
